▀ Report into fire at car dealer,
Brussels October 2014

TS14297-R01-ISSUE 1

for:
Kingspan Ltd
GreenField Business Park No 2
Greenfield
Holywell
Flintshire
CH8 7HU

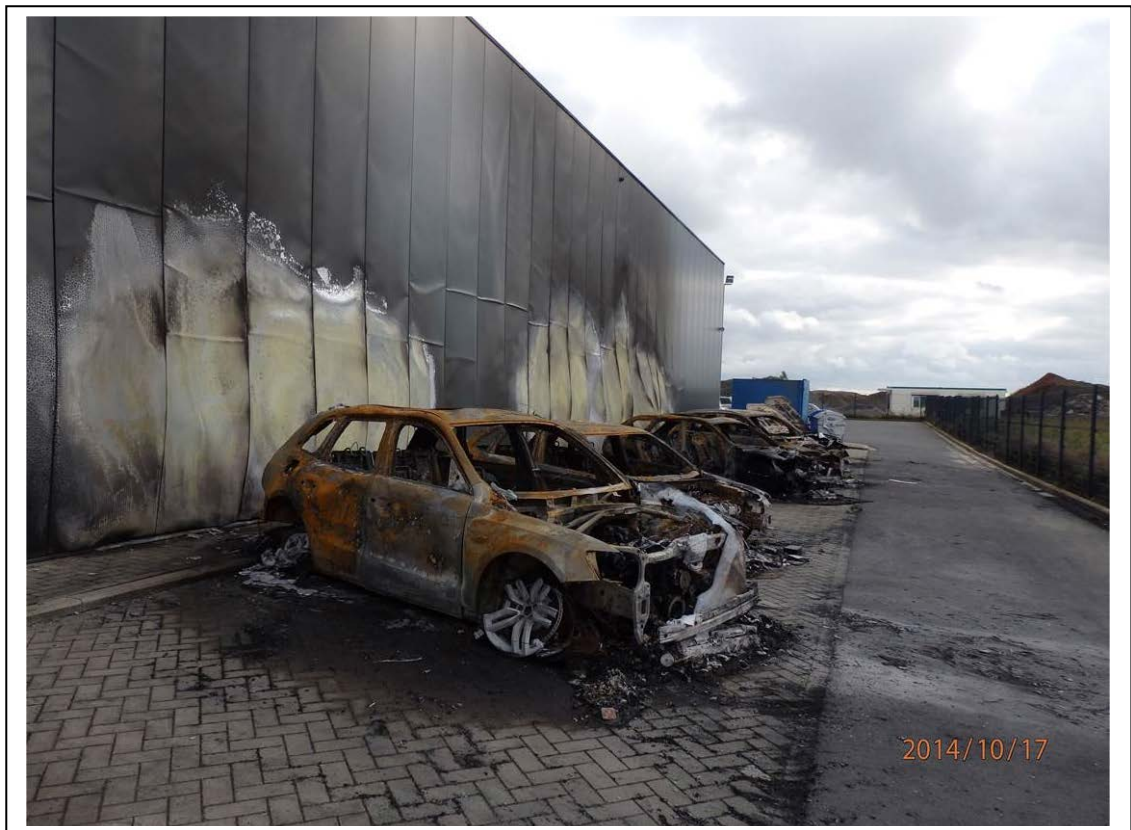
- 1.1 The fire occurred in the external compound of a large Audi dealership. It was a deliberately set fire.
- 1.2 Figure 1 shows the aftermath of the fire and is a photograph taken (by others) shortly after the fire event. The car in the foreground is understood to be an Audi Q3 with other cars being of at least a similar overall dimension and construction type.

Figure 1 – Aftermath of the fire

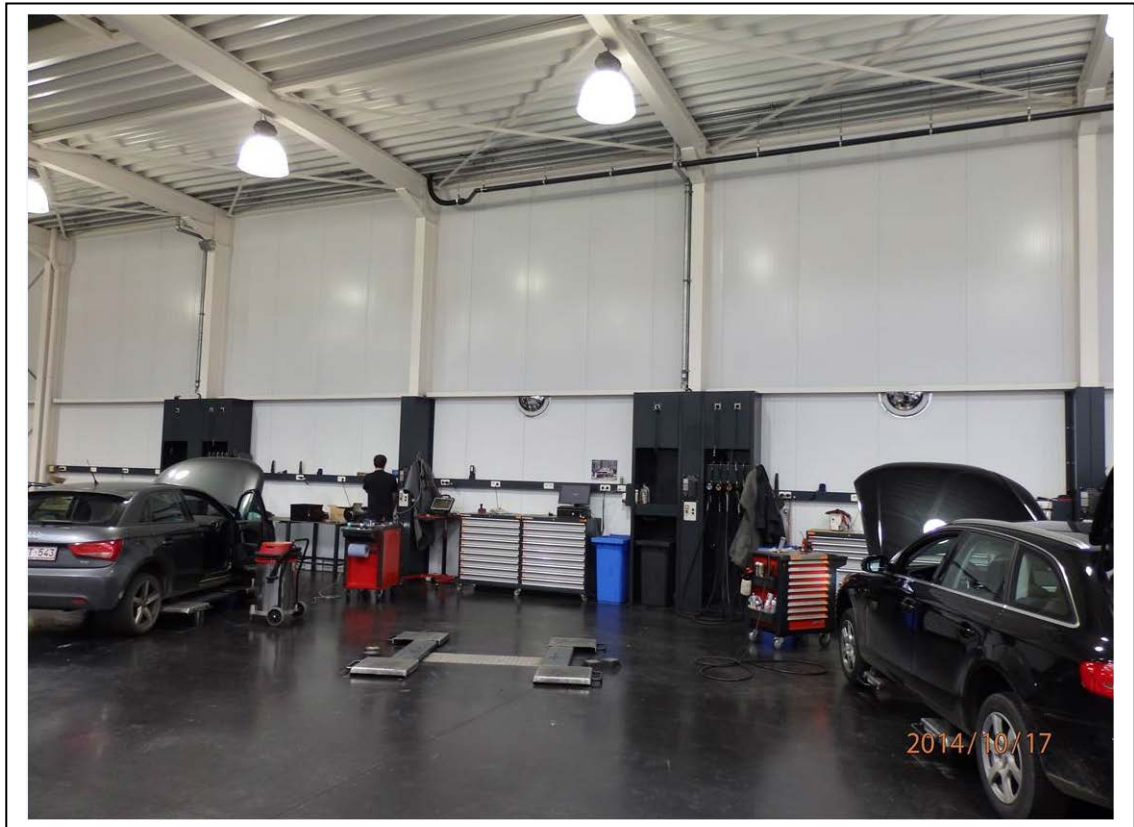
- 1.3 Figure 2 shows a photograph taken from the inside of the premises after the fire showing the inside of the external wall at the fire location and demonstrating that the fire had not penetrated into the interior of the premises.

Figure 2 – View of the inside of the fire-exposed external wall after the fire

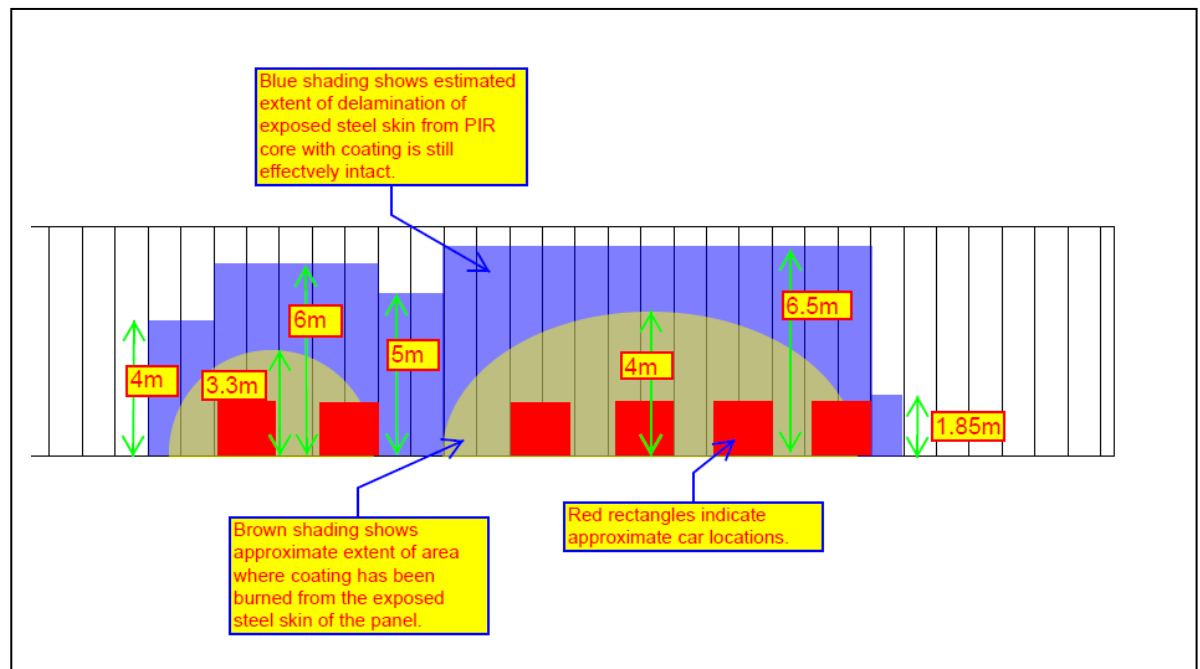
- 4.5 The scaled schematic in Figure 3 shows the key dimensions estimated from the site inspection.

Figure 3 – key dimensions on the exposed elevation showing car locations and extent of panel damage

- 4.6 What was clear from the relative positions of the cars and the damage exhibited by the panels was that the panel damage was offset slightly to the left (north) indicating that the flame front may have been influenced slightly by a prevailing wind in a northerly direction. Further evidence of this is provided by the condition of the damaged car which remained on site at the time of the inspection and which appears to have been parked furthest to the right of the elevation. The south facing side of this vehicle exhibited areas of undamaged paintwork and glass.

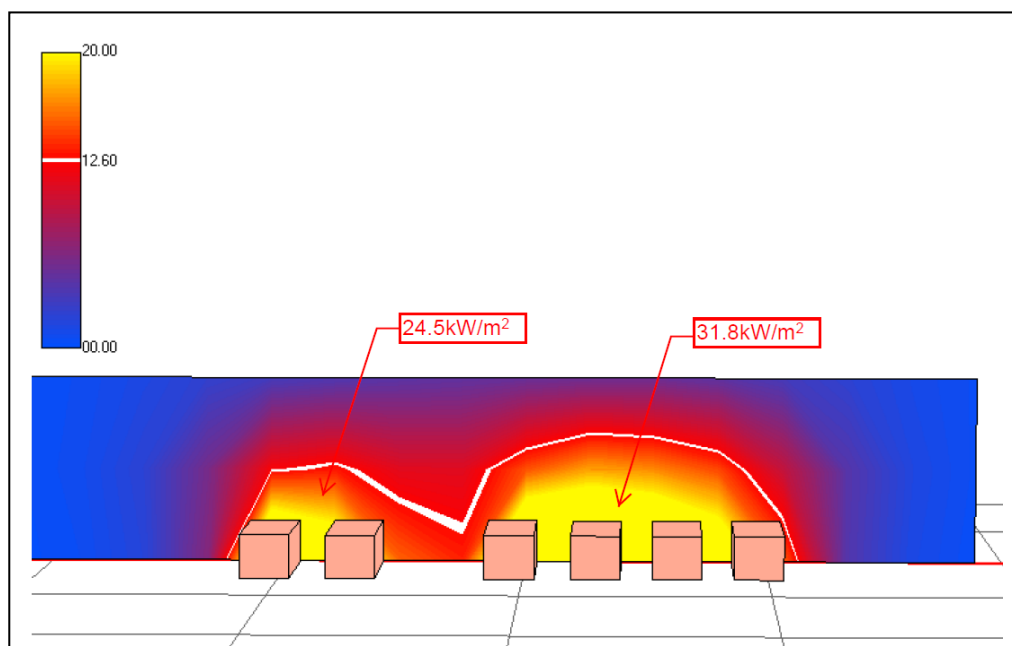
- 4.10 An estimate of the heat flux intensity incident on the cladding can then be made using the TenRAD^{6.3,6.4} model as shown in Figure 4. TenRAD is a 3-dimensional model that allows the radiative heat flux from a fire (or multiple fires) to be set up as a series of 'radiating panels' which can be set up at any angle relative to each other. TenRAD calculates by means of numerical integration the net received heat flux from these 'radiating panels' incident at the locations of interest. Locations of interest are set up as 'receiving surfaces' which can be oriented at any angle and distance relative from the 'radiating panels'. In this case the 'receiving surface' is the external façade of the building.

Figure 4 – TenRAD model showing estimate of radiative heat flux incident on cladding

- It is likely that the cladding will have been subjected to peak incident radiative heat flux of at least 31.8kW/m^2 for a period of at least 10 minutes.

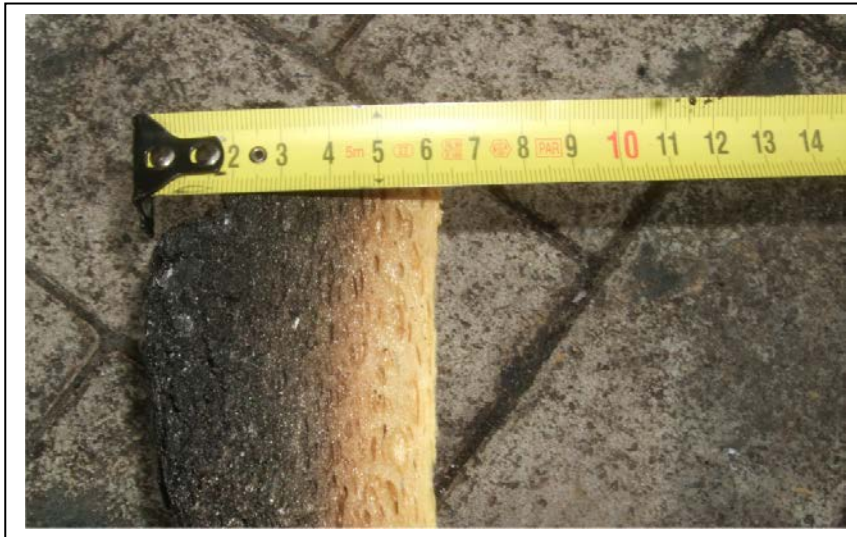
- 4.11 Figure 5 shows a sample of the PIR core material removed from the cladding panel at the location of predicted peak incident radiative heat flux of 31.8kW/m^2 . The photograph indicates that the PIR core had pyrolysed to a carbon char to a depth of about 40mm at this location.

Figure 5 – sample of PIR core removed from cladding panel at location of estimated peak incident radiative heat flux.

- The sandwich panels exposed to these conditions sustained damage in terms of delamination of the exposed steel skin of the panels away from the PIR core, removal of the paint coating and pyrolysis of the PIR core material to a depth of approximately 40mm.

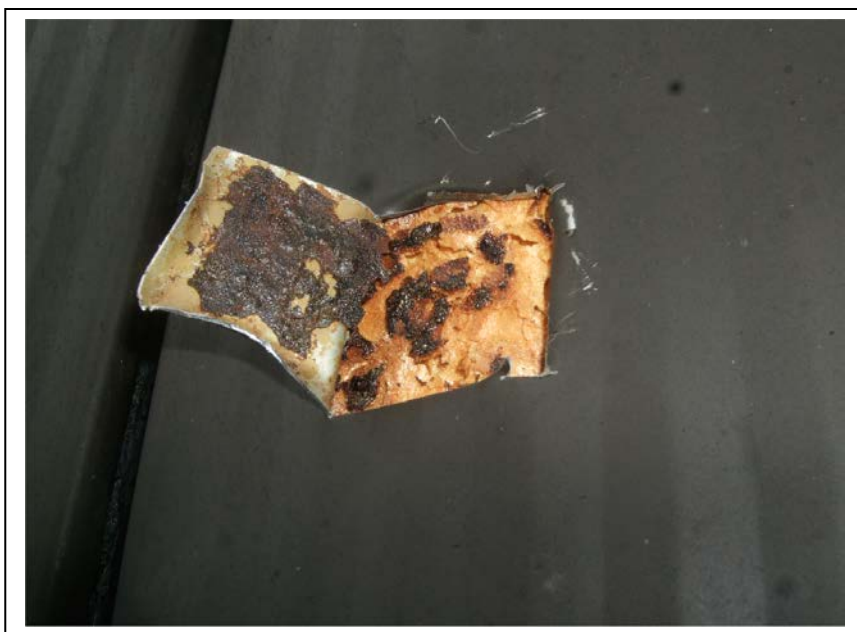
- 4.12 At locations remote from the area of peak incident radiative heat flux, the charring of the PIR core was significantly reduced, demonstrating that combustion had not been propagated by the PIR core material. Figure 6 shows an opened-up location where the panel had delaminated and just outside the area where the panel coating had been burned away. The photograph exhibits the breakdown of the bond interface between the PIR core with the steel skin but no significant charring of the PIR foam core itself.

Figure 6 – PIR core material at location exhibiting delamination but where panel coating is still intact

- There was no evidence of fire propagation within the panels.
- 5.4 The behaviour of the Kingspan PIR cored sandwich panels in this fire was therefore commensurate with that observed in previous fire case studies^{6,2}.
