▀ REPORT INTO A FURNITURE  
STORE FIRE, PRESOV,  
SLOVAKIA ON 28<sup>TH</sup> July 2012

TS12212-R01-ISSUE 2

for:  
Kingspan Ltd  
GreenField Business Park No 2  
Greenfield  
Holywell  
Flintshire  
CH8 7HU

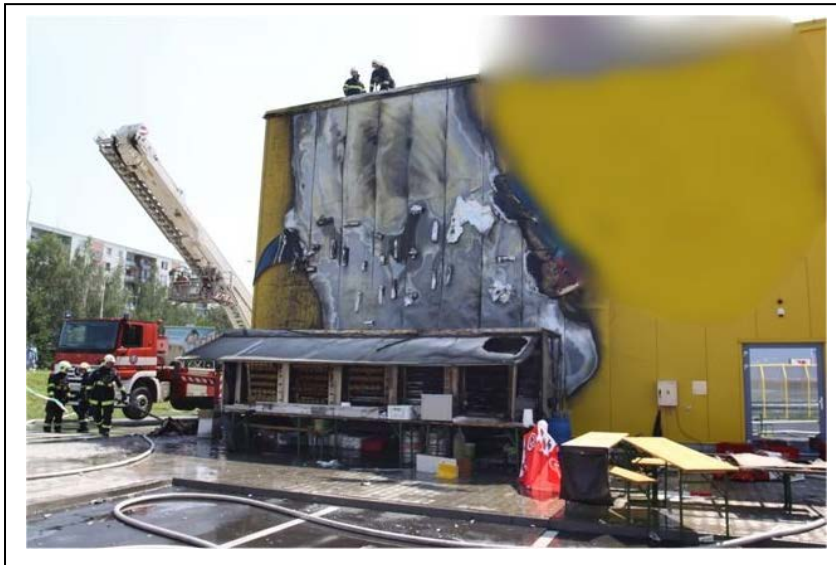
- 3.7 Fire-fighters stated that their initial perception was that the external wall panels of the building were burning. However, due to the rapid speed with which they were able to bring the fire under control on the outside of the building it became apparent that this was not the case as the fire seemed to be restricted to the external surface of the panels.

**Figure 2 – Photograph of the external wall of the building after the fire showing extent of fire impact on the external façade and the grill in the foreground.**

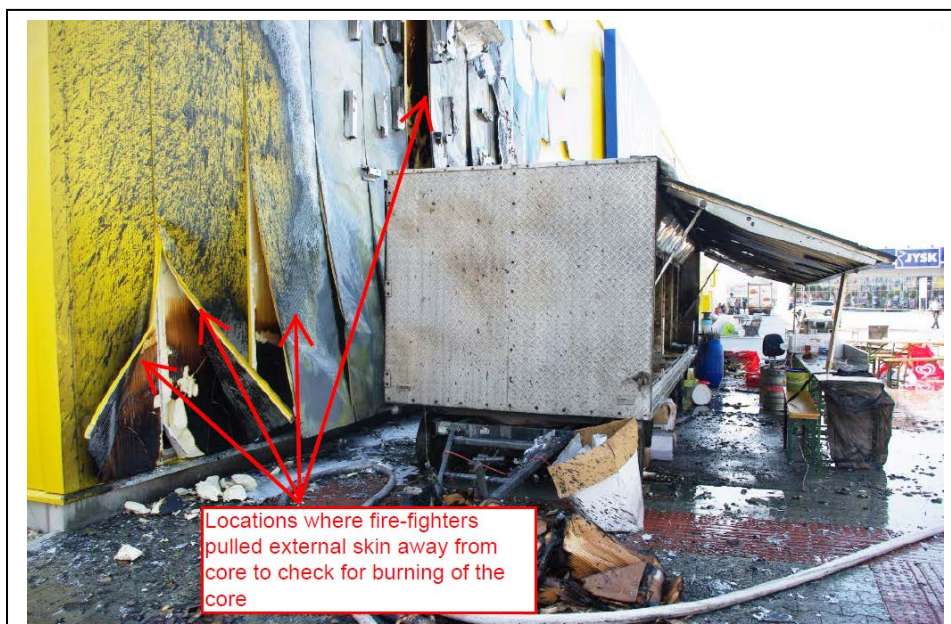
- 3.11 Fire-fighters pulled the external skin of the IPN cladding panels away from the core in several locations to check that the IPN core was not burning within the panel. No evidence of residual burning was found. Figure 3 shows where this was carried out by the fire-fighters.

**Figure 3 – Points where fire-fighters pulled external skin away from IPN core to check for burning within the core**

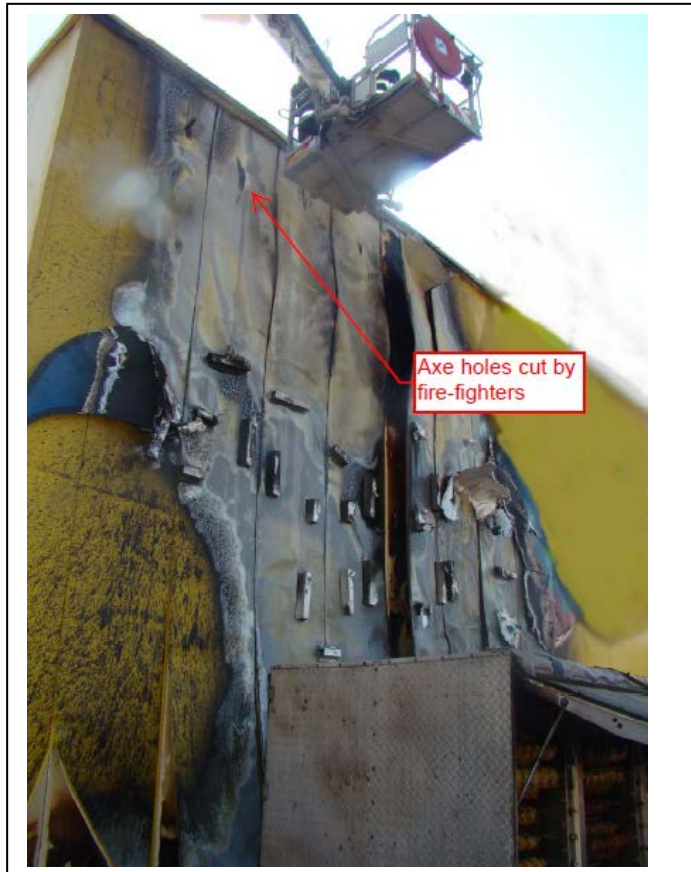
- 3.12 Fire-fighters also used fire axes to create holes at high level in the external cladding into which water was sprayed. Figure 4 indicates these locations.

**Figure 4 – Points where fire-fighters used an axe to cut holes in the cladding**

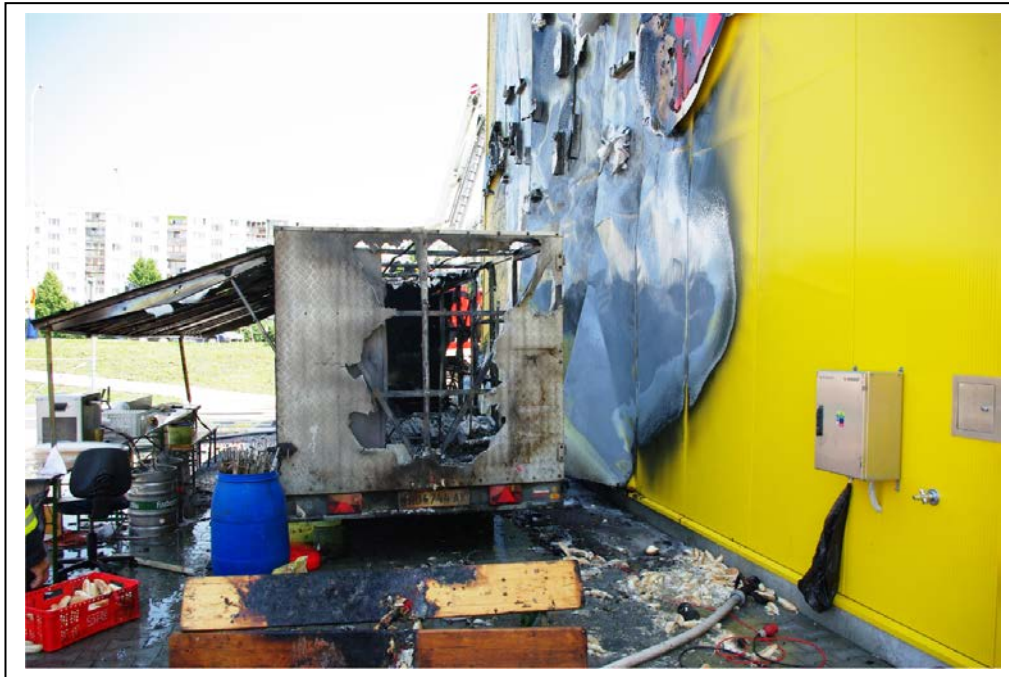
- 4.1 From photographs taken by fire-fighters and store management it is possible to estimate the distance of the mobile grill from the building at about 1.2m. Figure 5 shows the proximity of the grill to the building façade. The picture also provides an indication of the ferocity of the fire that engulfed the grill and which has resulted in complete destruction of the rear part of the trailer.

**Figure 5 – View of fire damaged grill showing proximity to the building facade**

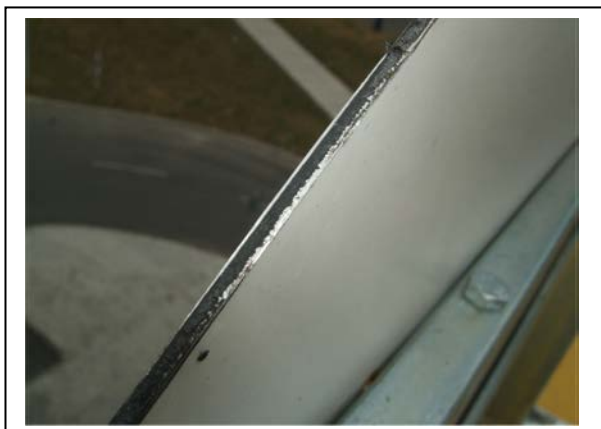
- 4.2 From the area where the fire has burned the decorative coating from the wall panel, the maximum width of the flaming region of the fire plume can be estimated as approximately 6m.
- 4.3 In this region, the store's large mascot sign had been completely destroyed with only the support brackets remaining. An inspection of the remnants of this sign showed that it was provided as an aluminium composite panel fabricated using two skins of aluminium sandwiching a polymeric interlayer with an overall thickness of about 6mm. Figure 6 shows the top edge of this panel in the area where it remained undamaged at the building parapet.

**Figure 6 – Top edge of the store's mascot sign showing aluminium composite panel construction**

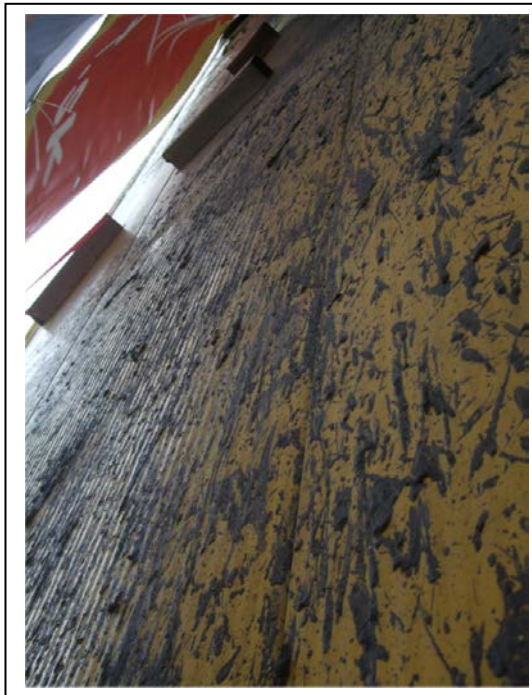
- 4.4 From evidence of melted aluminium from the sign at the foot of the external wall it was clear that fire plume temperatures had reached significantly in excess of 650°C (the melting point of aluminium) across the 6m width of the external wall construction where the sign had been destroyed and the coating of the wall panels had been burned away.
- 4.5 From the shape of the fire plume impact on the surface of the building it was evident that the wind direction at the time of the fire was from west to east. To the east (left hand side) of the area affected by the fire plume there was a significant amount of unburned thermoplastic core material from the sign that had been melted by the fire plume and a had been blown by the prevailing wind condition onto the unaffected part of the façade where it had solidified. Figure 7 shows this material on the surface of the panel.

**Figure 7 – Melted thermoplastic core material from the aluminium composite panel sign**

- The intensity of this fire plume was such that it was capable of melting the aluminium composite panel used for the store's mascot sign within this short fire exposure period.

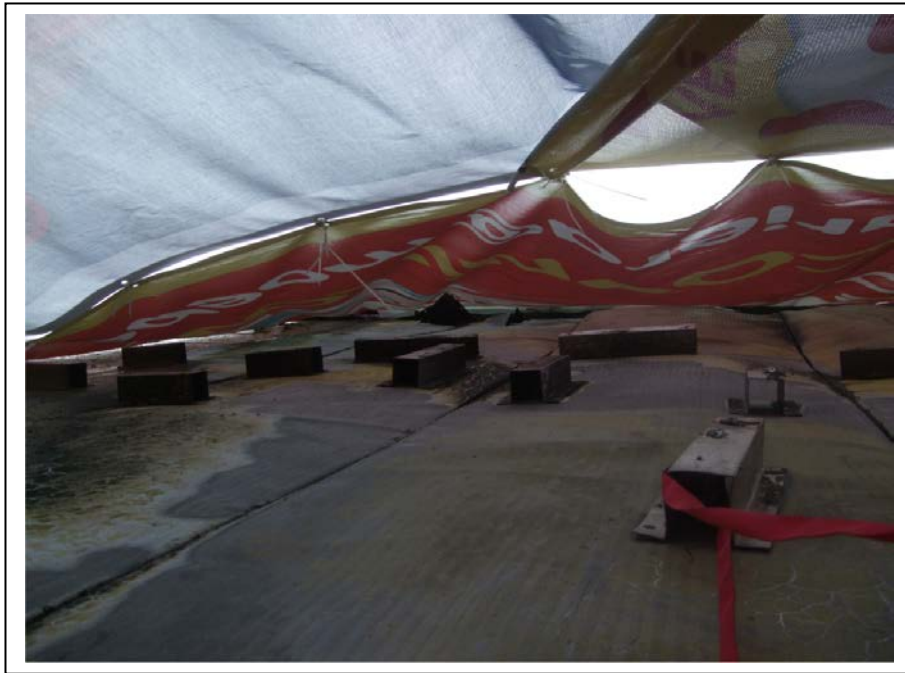
- 4.6 In the area where the fire had burned away the sign and the wall panel coating, there was no evidence of any melted thermoplastic core material on the external surface of the wall panels (as indicated in Figure 8). It is therefore clear that combustion of this thermoplastic material took place within this zone

**Figure 8 – Close up of surface of panels in area where sign and panel coating have been burned away (the top hat sections are the fixing brackets for the sign)**

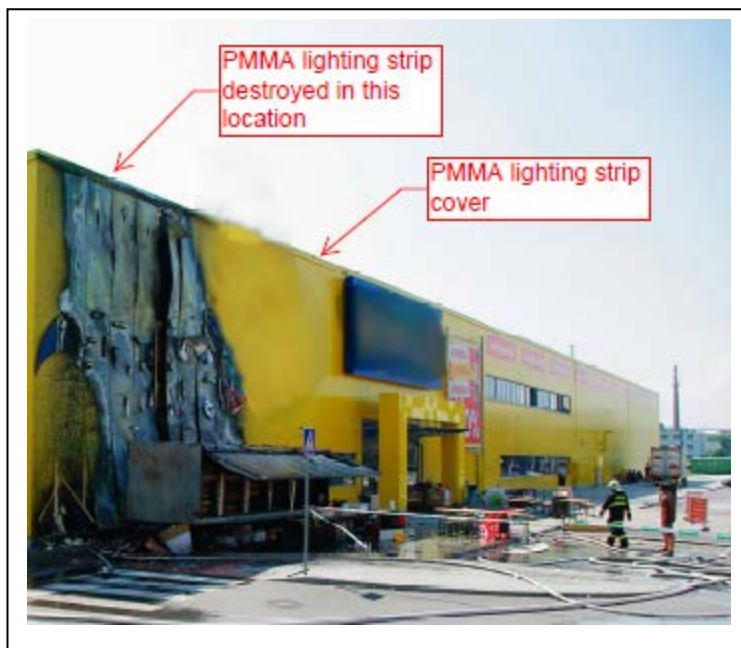
**Figure 9 – Lighting detail at parapet**

4.7 At the top of the external wall, the parapet detail was provided with a translucent yellow lighting detail around the perimeter of the parapet. This appeared to be formed using Poly(methyl methacrylate) (PMMA) material and there was also evidence of this melting into the fire plume. Figure 9 shows the location of this detail and Figure 10 shows a piece of the melted material which was hanging from the parapet just outside of the zone impacted directly by the fire plume.

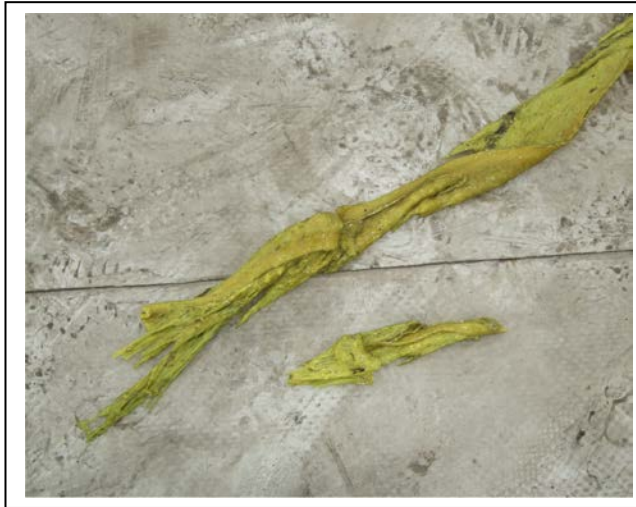
**Figure 10 – Melted parapet lighting detail**

- There is clear evidence that combustible materials used in the construction of the store's mascot sign and parapet perimeter lighting strip contributed to the intensity of this fire plume and would have been instrumental in the fire-fighters' initial opinion that the external wall construction was also burning.

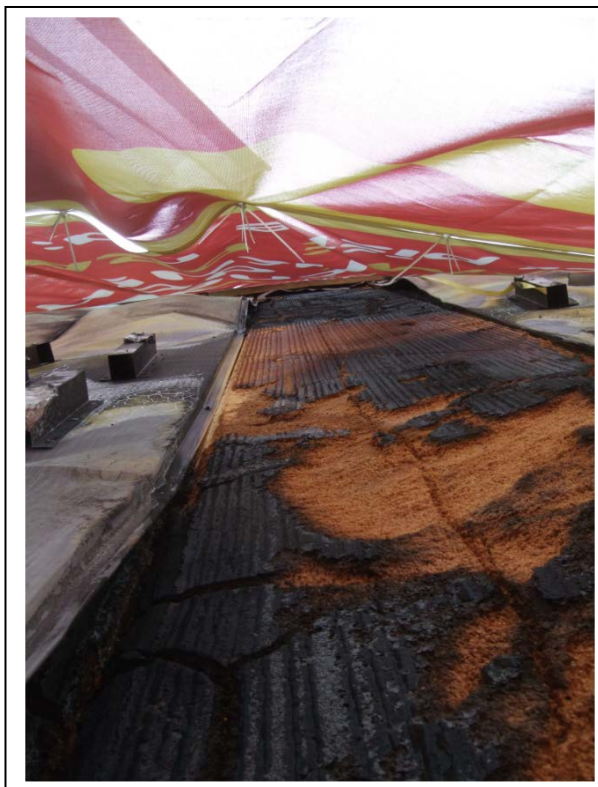
4.8 Figure 11 shows the effect of the fire on the IPN core material of the wall panels in the region impacted directly by the fire plume. In this location the external skin of one panel section was completely removed prior to weather protecting the building using the tarpaulin. This was carried out for health and safety reasons as the external steel skin of this panel was almost completely removed by fire-fighters during their inspection to confirm that the building was safe.

**Figure 11 – Charring of the IPN core of the external wall panel**

- 4.9 The IPN core had exhibited charring to a depth of approximately 10mm. There was no evidence of fire propagation in the core as evidenced by the transition from charred core to un-charred core at the boundary of the impact area of the fire plume (shown in Figure 12).

- The IPN core material of the external wall panels charred to a depth of about 10mm in the area directly impacted by the fire plume and the external skin of the panels delaminated from the core in these areas.

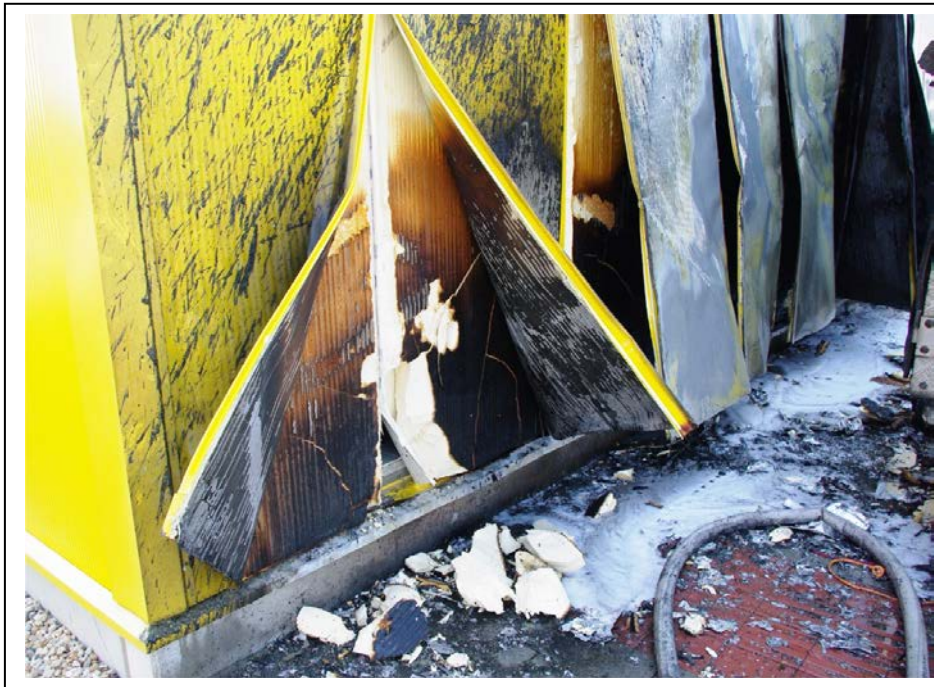
**Figure 12 – External steel skin of IPN panel pulled back to show unaffected IPN core material outside area of direct fire plume impingement**

- Despite the intensity of the fire plume, the IPN core did not propagate the fire within the panel construction to areas within the core remote from the area of direct fire plume impingement.

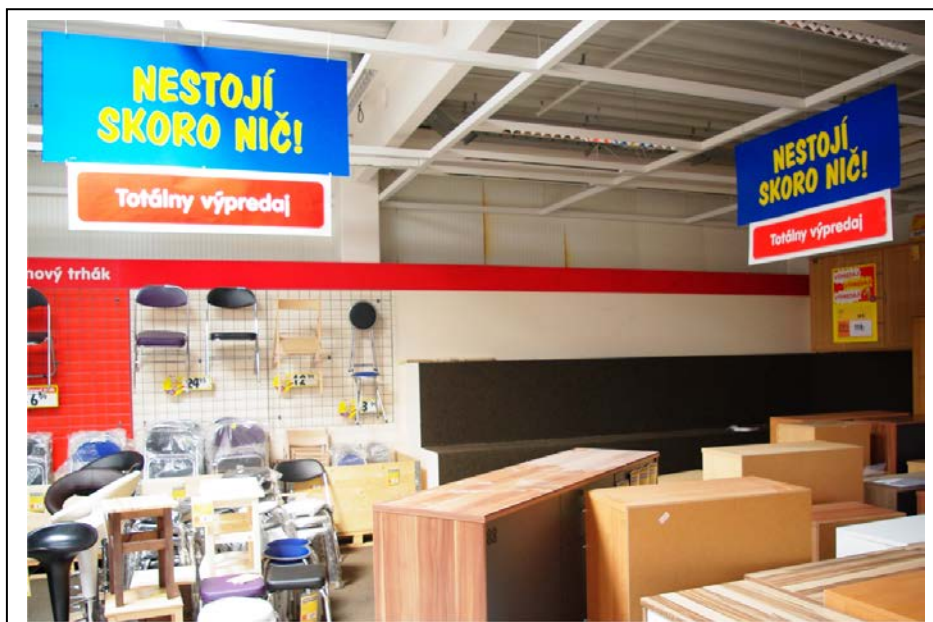
- 4.10 Inside the store, there was no evidence of fire penetration other than some staining due to smoke penetration at panel joints in the area of direct fire plume impact on the outside of the building. This is shown in Figure 13. There was no evidence of delamination of the internal skin of the panels from the IPN core.

**Figure 13 – Staining of panel joints on inside surface of wall in area of direct fire plume impingement**

- The effects of fire in the store were limited to minor smoke ingress at joints between IPN panels in the area of direct fire plume impingement. There was no spread of fire into the store. The effects were minor enough that the store was able to open about 3.5 hours after the fire.
